REFRACTORY DESIGN EFFECT ON SUBMERGED ARC FURNACE LIFE AND PRODUCTION PERFORMANCE – THE ZIMBABWE ALLOYS EXPERIENCE

J. Chirasha and N.R. Shoko

*Zimbabwe Alloys International P.O. Box 530, Gweru-Zimbabwe
E-mail: jchirasha@zal.co.zw and nshoko@zal.co.zw*

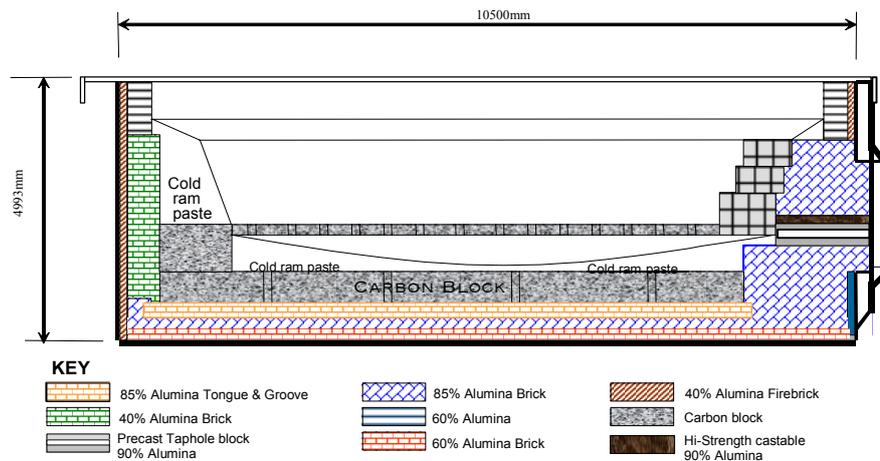
Figure 1: Refractory Lining Section

Zimbabwe Alloys designed and lined its HCFeCr Furnace as shown in Figure 1.0. It was later found out that expansion for the entire lining of the furnace was not provided for. Bricks were lined directly against the shell. More over the brick to brick expansion was not adequate allowed for from the base of the furnace to the furnace side walls.

Refractory type and quality was verified correct. There was no provision for expansion gap. Bricks were lined or put against the shell on the sides and therefore during expansion they pushed out the shell in all directions but more severely around the taphole area as this was the weakest area of resistance as a result of activity related to the tapping operation. Expansion also between the bricks themselves was not provided which created even a bigger force on the shell.

- (i) A 75mm gap was left between the new refractory and new shell.
- (ii) An expansion gap of 2mm between the bricks was left.
- (iii) New taphole block installation to the original position.
- (iv) A ceram GT90 carbon based material filled the 75mm expansion gap.

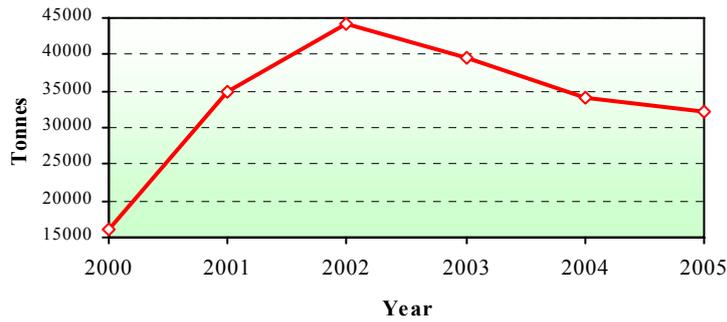
Figure 2: HCFeCr Production

In 2003 production started deteriorating and bottomed at 32000 tonnes in 2005, a 30% reduction from 2002 production although the furnace running time was constant.

Figure 2 to 4 indicated a significant unfavourable shift on production, kwh/t and recovery from 2003 to 2005. This was a major signal flagging on the furnace performance to the effect that something was still not original on the furnace.

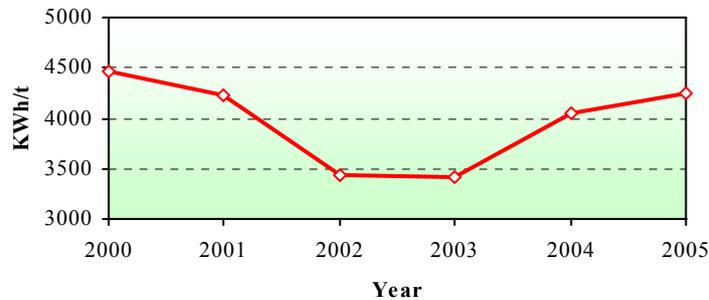
Figure 3: HCFeCr Specific Power Consumption

The specific power consumption (KWh/t) which is a direct measure of furnace efficiency utilization of power improved from 4500 kwh/t to the lowest figure of 3400 kwh/t between 2002 and 2003. A value of power utilization of this magnitude could qualify to be one of the best in the conventional HCFeCr process.

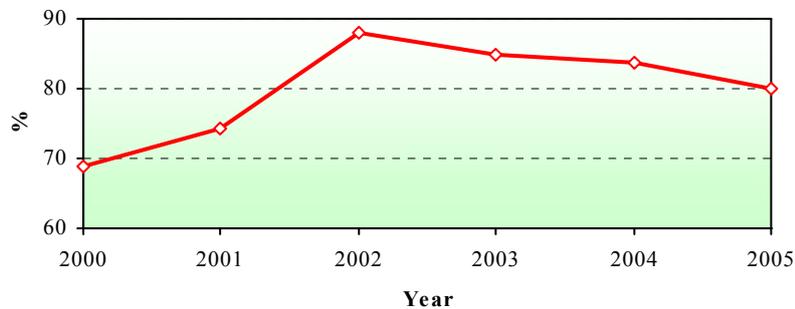
Figure 4: Chromium Recovery

Figure 4 below shows the recoveries recorded in the period under review. A visible deterioration of recoveries from 2003 to 2005 showing poor furnace performance.

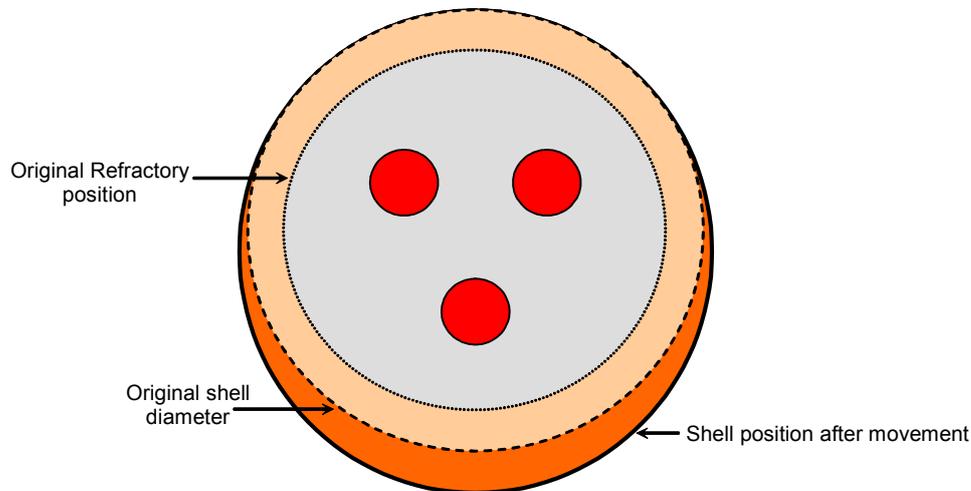
Figure 5: Furnace plan showing relative movement

The front section of the shell as an effect of the force on the base movement displaced about 600mm outwards together with tap launder. A view of the furnace from the top showing the new shell position as compared to the original position is shown in Figure 5.

The taphole lifted 400mm up and 200mm sideways to the right. Weak zones were created and the furnace shell started cracking vertically from the base upwards on either side of the taphole.

It was suggested to cut-off the bolts joining the furnace flange and the base plates to release the tension. After this, the base plate got to its original position but the furnace flange remained up leaving a 400mm gap exposing the refractory. A 400mm wide plate was rolled and welded to close the gap to protect the refractory.

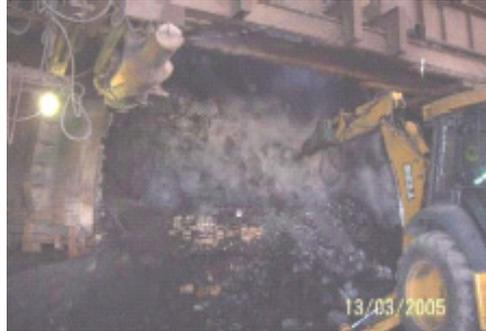
Figure 6: Furnace digging in progress

The shell area around the taphole was removed to cover 43° on either side of the shell to facilitate the furnace digout and replace the refractory. Digging was done into the feed zone on this part of the section.

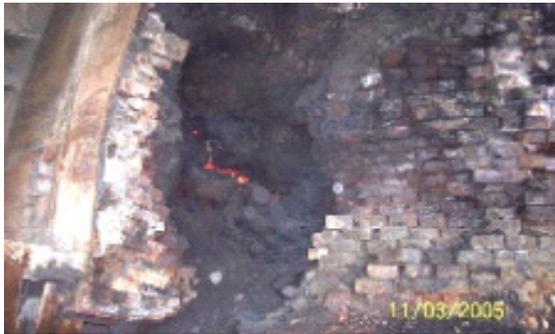
Figure 7: Left side Cavity after brick movement due to distortion

The right side of the taphole had suffered severe refractory movement as was seen by distorted brickwork. On the left side, the movement left a big cavity between the shell and some refractory bricks.

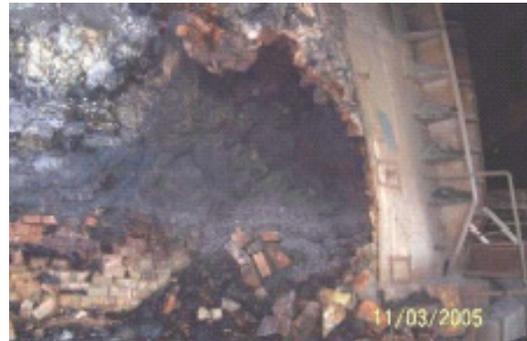
Figure 8: Right side Cavity after brick movement due to distortion

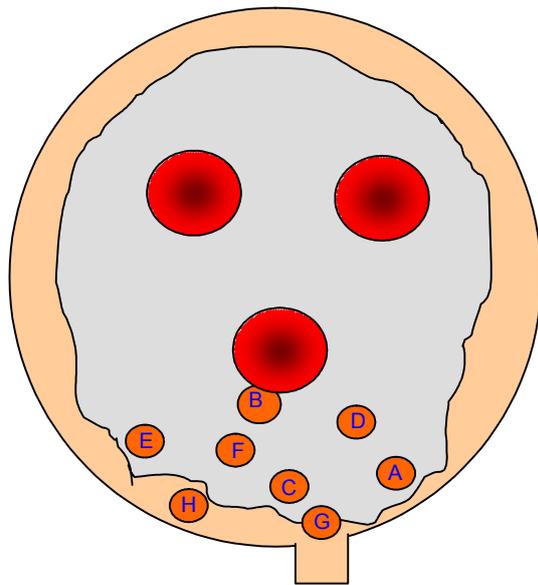
Figure 9: Analysis of Material from Dig-out Area

Figure 9 below shows the analysis of samples taken at different and related points during furnace digout. A mixture of fused, semi-fused and unfused raw materials were observed together with metal and slag.

The expansion of bricks and the subsequent distortion left weak zones in the refractory lining, these were observed as the alloy and slag were found between layers of distorted refractory bricks which areas caused breakout.

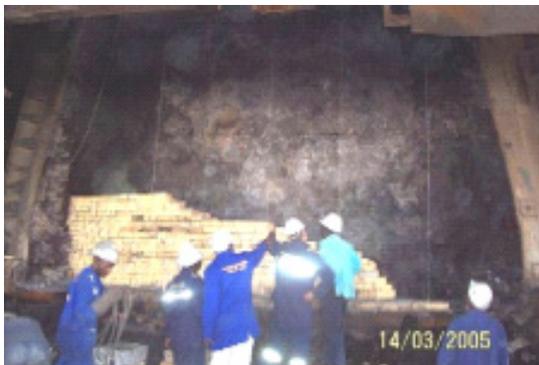
Figure 10: Initial stage of Refractory Installation

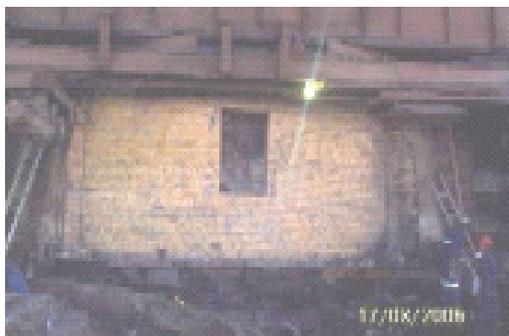
Figure 11: Final stage of Refractory Installation

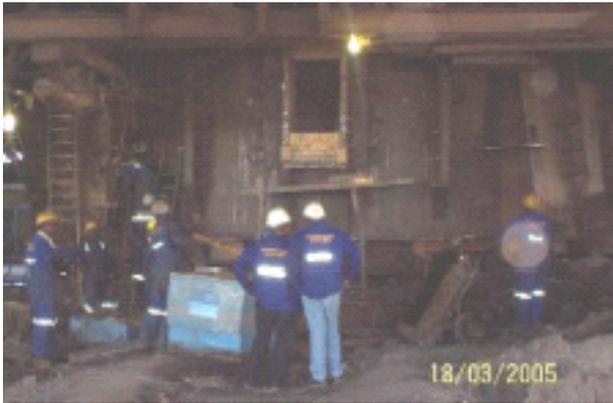
Figure 12: Complete Refractory and Shell Installation

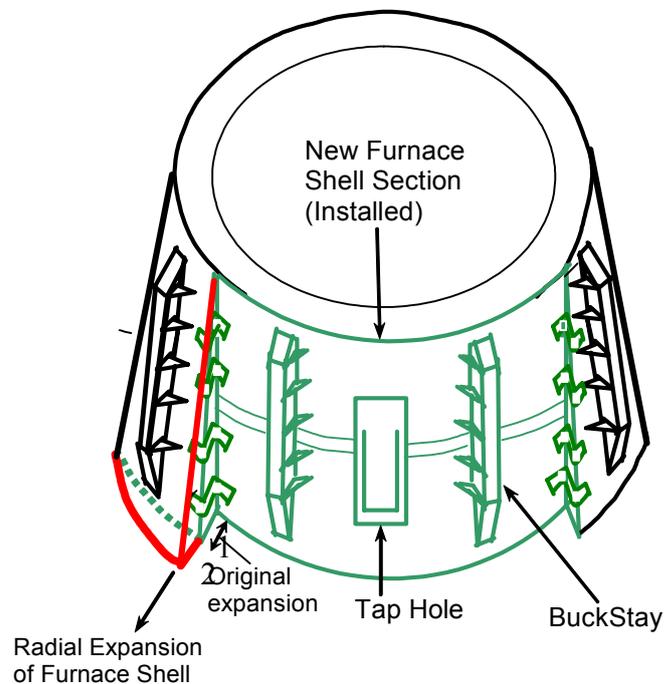
Figure 13: State of Furnace after repairs

Figure 13 below shows the new shell in position relative to the old one.

The furnace base cooling was also modified in the process and furnace side walls in front of the taphole had cooling mechanism installed. The repair lasted 14 days.

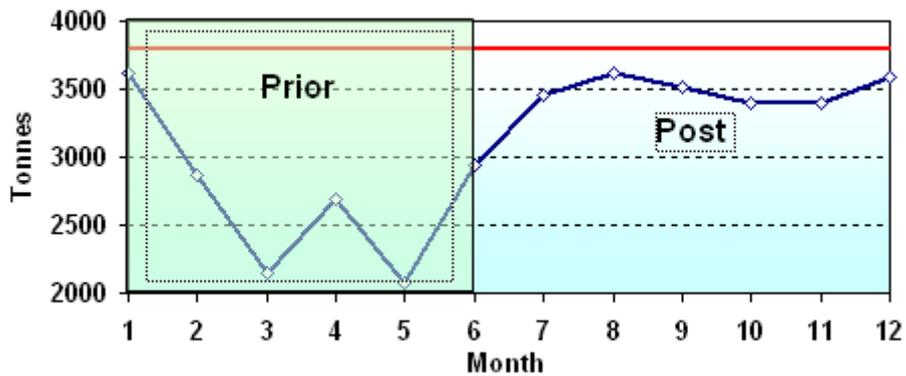
Figure 14: Production

Production improved by 5622 tonnes for a period of six months (36.6%) after furnace repairs. The chromium recovery significantly shifted to close to 90% after the furnace partial rebuild.

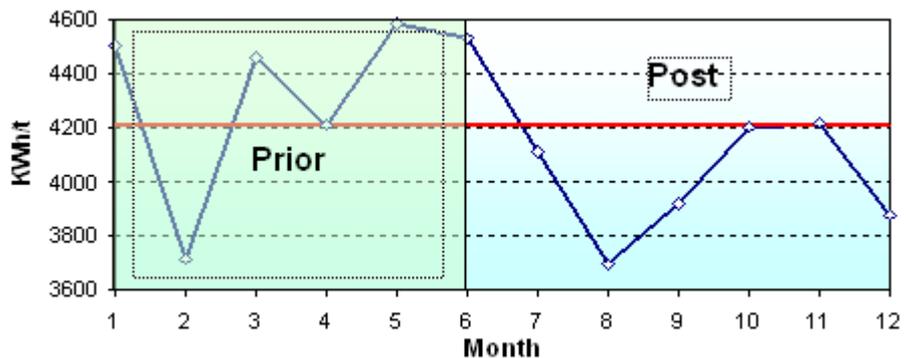
Figure 16: Specific Power Consumption

There was a significant shift on furnace output, kwh/t and recovery after the furnace repairs.
