BURN DOWN, EXCAVATION AND RELINING ENS12 2013/2014

ABSTRACT

This report describes the condition of the ErametSauda High Carbon furnace 12 immediately prior to relining, observations during the excavation of the furnace and the relining of the furnace in 2013. This furnace was last relined in 2002 with 50 cms high carbon blocks / freeze lining concept. Shortly after start-up lifting of the lining was observed and continued in the following years until relining in 2013. During this period the lining condition was continuously monitored using thermocouples in the lining and periodic heat flux measurement by measuring the shell cooling water flow and temperature rise. Periodic injection of grouting paste was made in an attempt to keep good contact between the hot face and the cooled shell. During the dig out the penetration of slag between the blocks which resulted in the lifting and tilting of lining was confirmed. In addition 6 samples from the burden and banks around the sidewalls were taken in order to increase process knowledge. The new lining is based on the large block / freeze lining concept to avoid penetration of liquids in the joints. Experience to date shows that this con

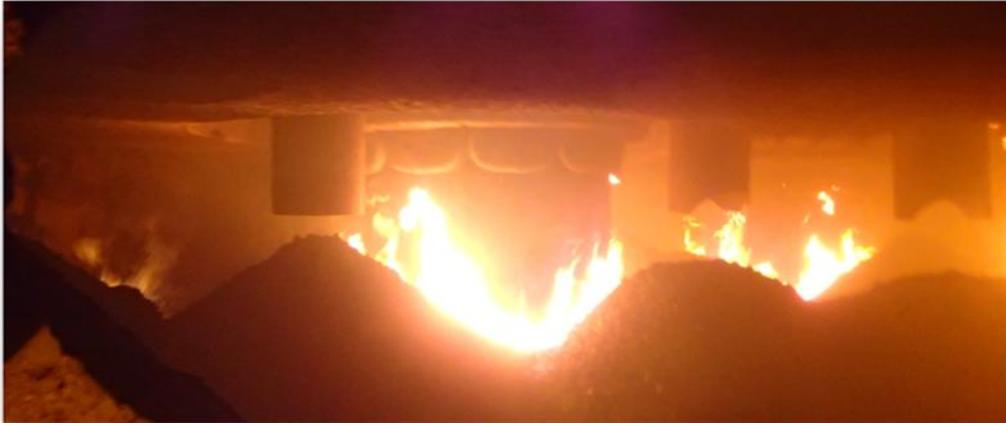
Figure 2: Area around A electrode shortly after burn down started

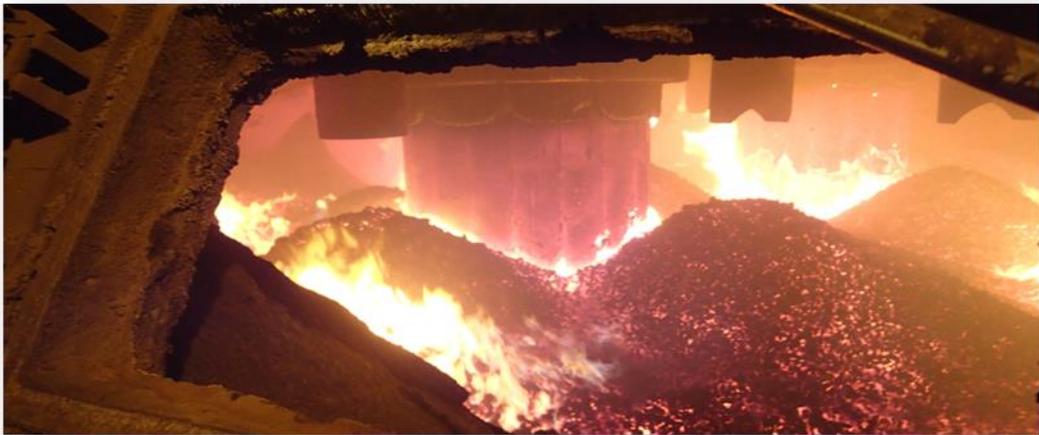
Figure 3: Area around A electrode during burn down

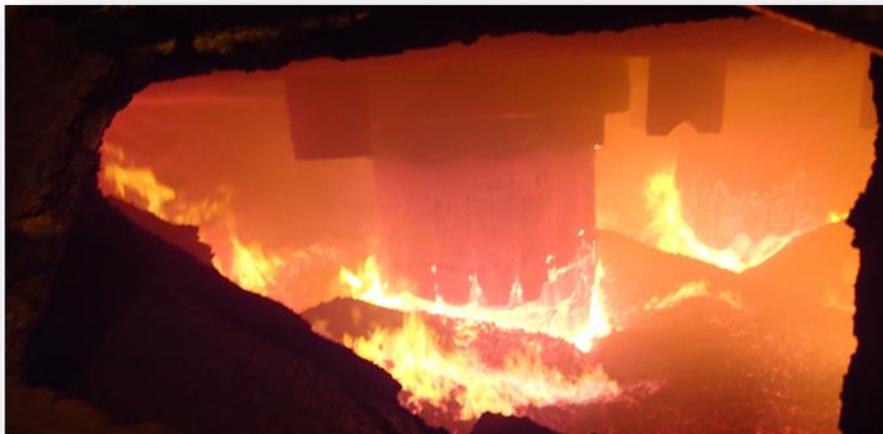
Figure 4: A el during burn down

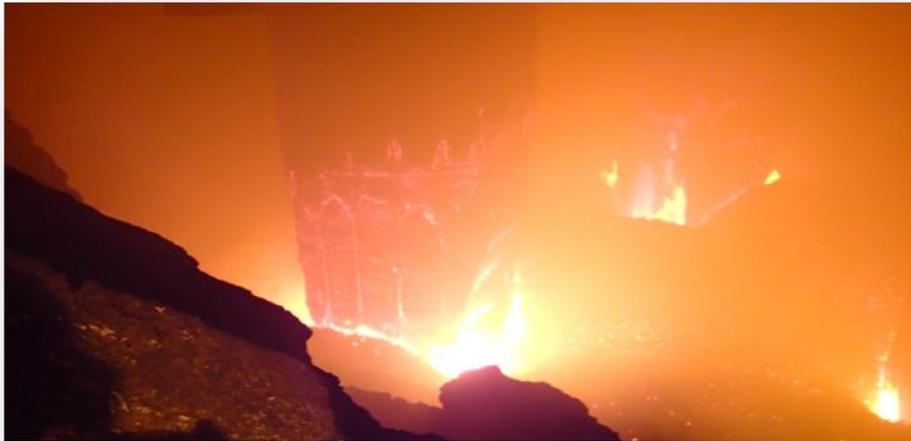
Control below cover after stop showed very good effect of burn down. Mix burden was approximately 2-3 meters below mix chutes. Figure 2-5 shows the electrodes and charge during the burn down process.

Figure 5: Area around A electrode after burn down

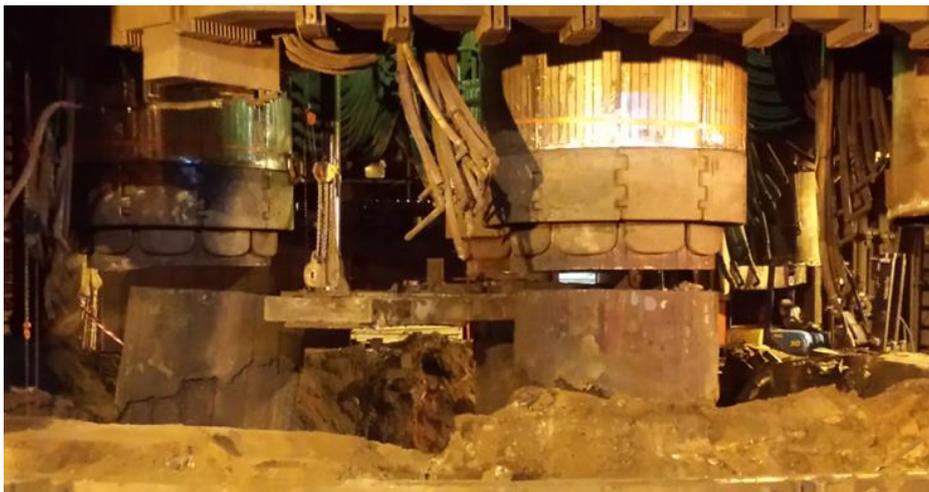
Before excavation started the electrodes were cut below clamps. The tool used for cutting was a diamond impregnated wire. Fig. 7 shows two of the electrodes after cutting.

Figure 7: Furnace cover removed and electrodes after cutting

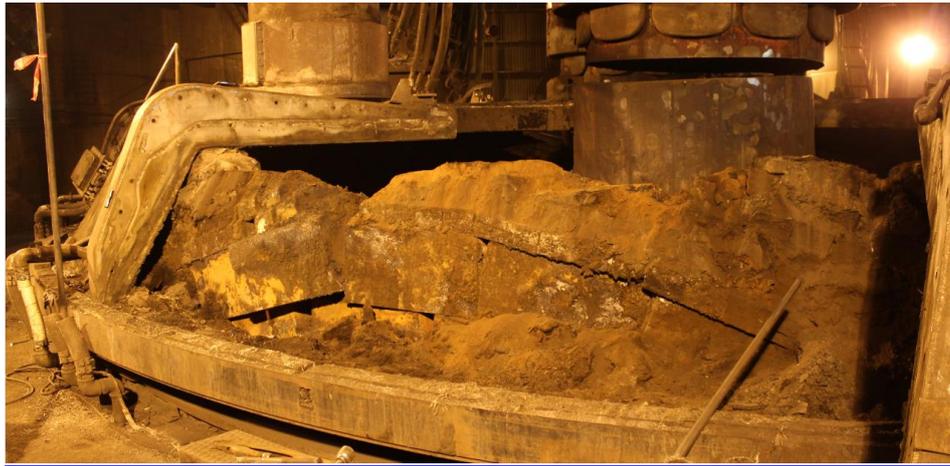
Figure 8 shows the lifting of the side-wall lining blocks during removal of the furnace cover.

Figure 8: Lifting of carbon blocks in side wall

Excavation has showed that an unstable freeze lining and water leakages can contribute to slag penetration in horizontal joints and lifting of the side wall lining. Hypothesis for lifting are stops and water leakages that lead to an unstable freeze lining. When the furnace was warmed up after stops, the freeze lining attached to the hot face of the lining expanded more rapidly than the carbon blocks, lifting the hot face and thereby opened gaps between blocks. To reduce slag penetration in the new lining we used large carbon blocks with few horizontal joints. No lifting has been observed since start up in February 2014.

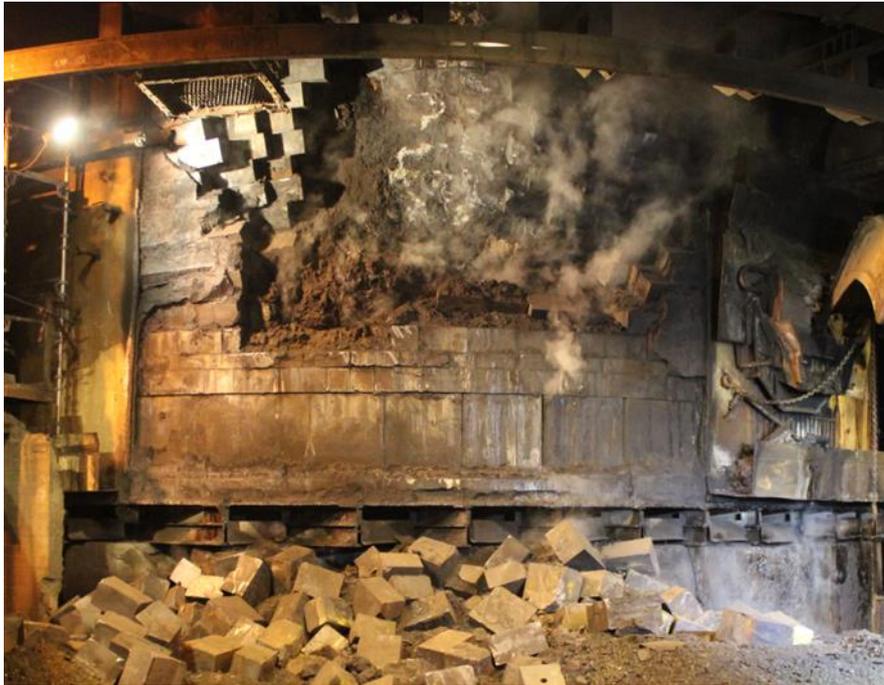
Figure 9 and 10 shows the opening made in the furnace shell between the two metal tapholes to remove the old lining and charge materials. There seemed to be no lifting in the lower parts of the furnace, but in the upper side walls the blocks were tilted and lifted. The carbon blocks themselves are not worn or damaged

Fig 9: Area outside B el. Lifted blocks

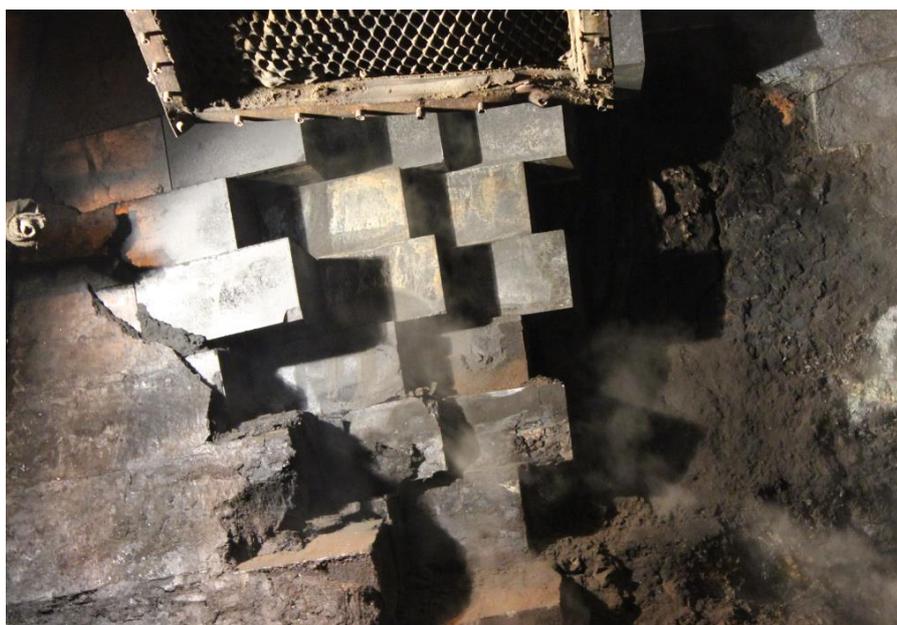
Fig 10: Lifted blocks in area left of tap hole A side

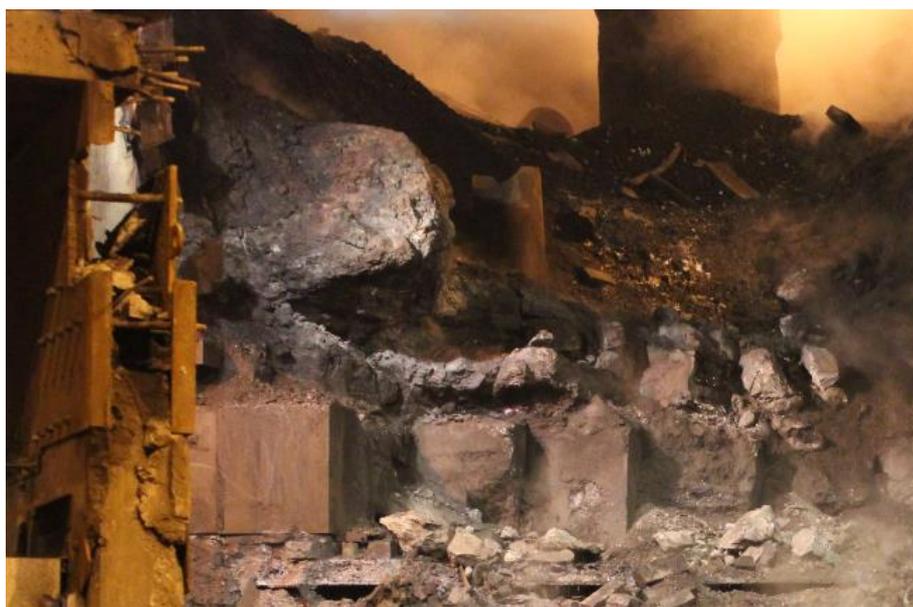
During excavation we discovered several banks in areas between electrodes. Samples from burden were taken with assistance of people from Eramet Research. A discussion of the analysis of the burden is beyond this report.

Fig 11: Bank in area left of tap hole A side

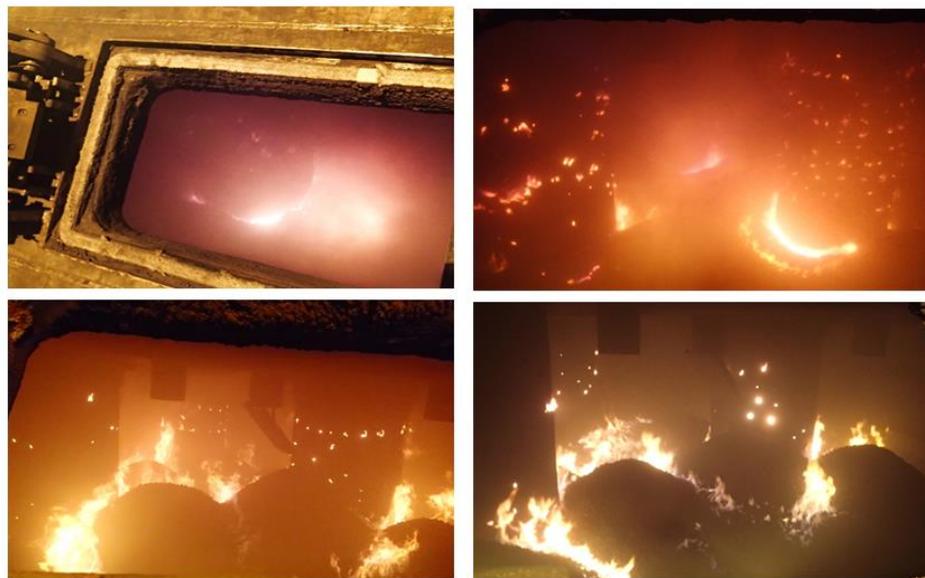
The furnace was started up in star connection on the 10th of February at 14:20. Starting up was successful with immediate contact on all electrodes. Addition of mix was done regularly during ramp up in order to avoid high temperatures/radiant heat. Fig.15 shows electrodes and mix burden during ramp up.

Fig 13: Mix burden during ramp up

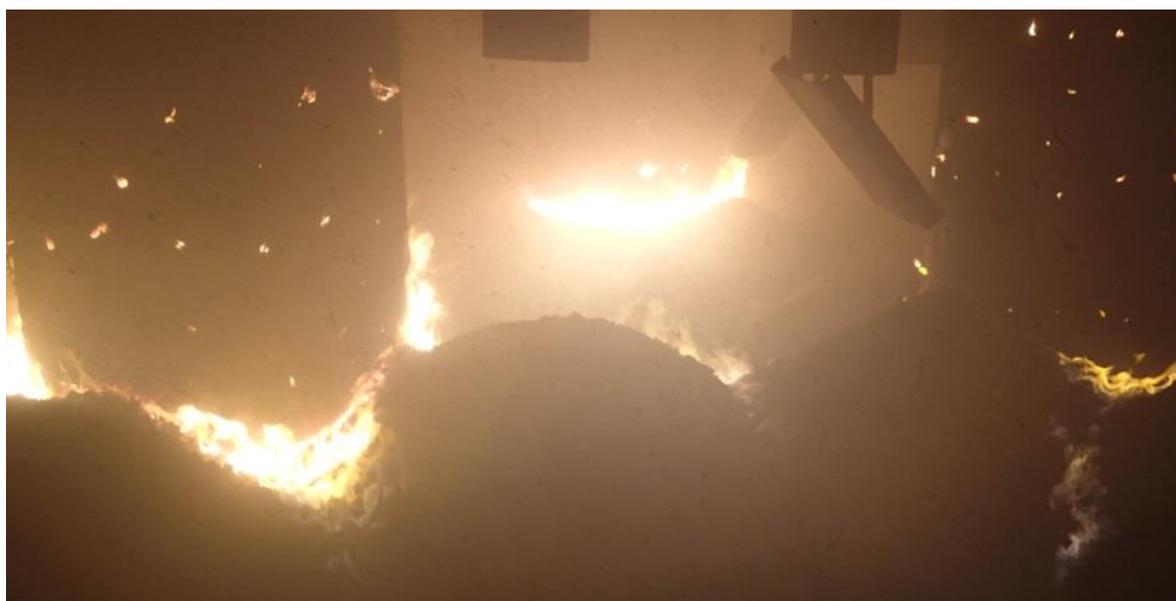
Then a breakage occurred on A electrode approximately 1.5 meters below clamps. The electrode was slipped 1.5 meters. This was followed the day after by a new breakage on B el.

Fig 14: Electrode breakage A and B el
