IMPROVED SAFETY FOR MANGANESE ALLOY SMELTING

¹P.A. Eidem, ²K.A. Egeland ³D. Baumann

Eramet Norway AS, Po.Box 82, N-3901 Porsgrunn, Norway,
e-mails: ¹per-anders.eidem@erametgroup.com, ²knut-arild.egeland@erametgroup.com,
³dag.baumann@erametgroup.com

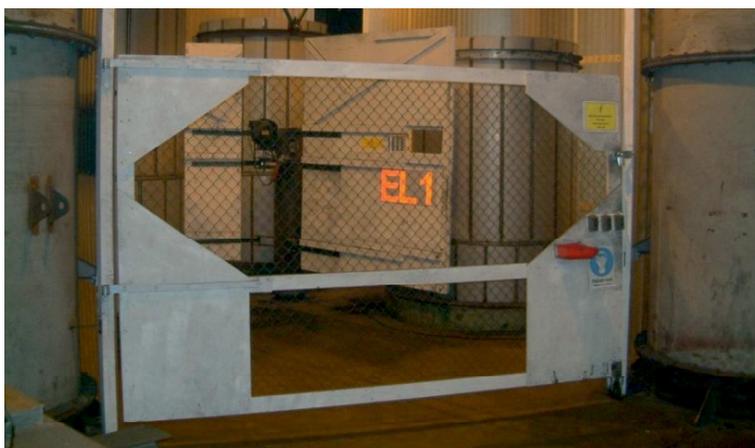
Figure 1: A locked gate restricts the access to the electrodes, and isolating plates have been mounted between the electrodes to prevent contact between them

At the 4th floor there are now physical barriers to restrict access to the critical areas. To prevent electrical contact between the electrodes and from an electrode to ground, isolating plates have been mounted on the floor and between the electrodes, as shown in figure 1. The picture also shows the isolating walls separating the silo tubes from the electrode area.

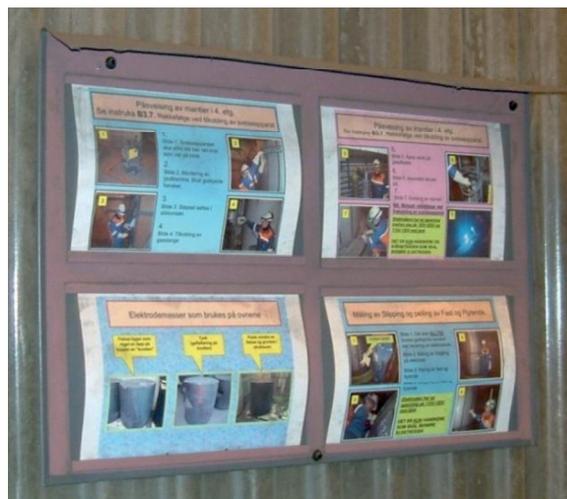
Figure 2: Procedures are posted and illustrated clearly by pictures

A clear description of the area and work procedures for that area is posted. Pictures are used to describe the procedures in a clear manner, as shown in figure 2. Standard protective wear for people in contact with electrodes now include dry clothing, dry shoes and special isolating rubber gloves to increase the physical barriers. Wooden ladders are used when needed. There is also a focus to keep a tidy work environment.

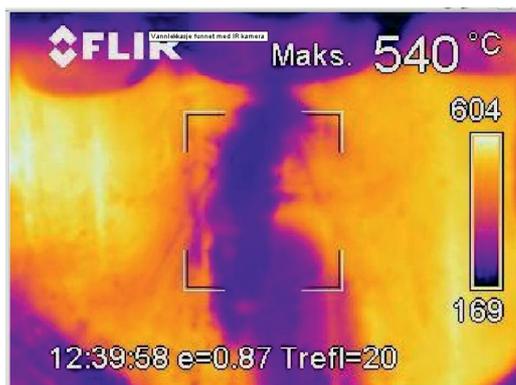
Figure 3: Water leakage under the furnace roof detected by an IR camera (picture taken by Haraldsen, Eramet Norway AS)

One of the methods for detection of water leakages in the furnace is an IR camera. This is used today for inspection under the furnace hood and helps to overcome fumes and dust that often cause a problem for getting a clear view. An example is shown in figure 3 where a water leakage hitting an electrode can be seen as the dark area. However, success with the hand held IR camera requires a trained user and that the water leakage hits a visible hot area in the furnace, such as an electrode. As a result, there are different opinions on whether or not this is a useful tool for identifying leaks. An idea for an online surveillance system was to mount IR cameras on hatches around the furnace vicinity, as shown in figure 4.

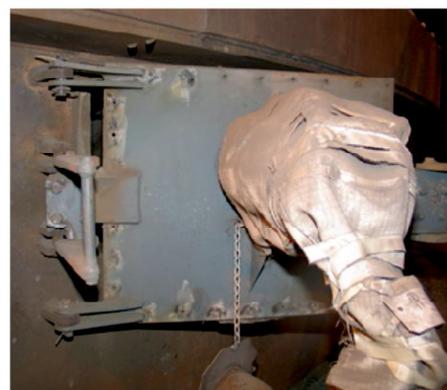
Figure 4: IR camera mounted on one of the hatches of the furnace roof. (Picture by Iversen 2007)

Part of the problem encountered was that the view was clogged by dust. A possible solution for this would be purging the area in front of the lens by nitrogen. In addition by drawing a simple coverage map of the areas that would be covered by mounting cameras revealed that a lot of cameras would be needed to cover the charge top, and the area between the electrodes would be a challenge to cover in a satisfying way. During an evaluation of water leakage systems in 2009 it was decided not to go further with this system due to the poor coverage and questionable ability to detect small water leaks. Hand held IR cameras are used today for inspection.

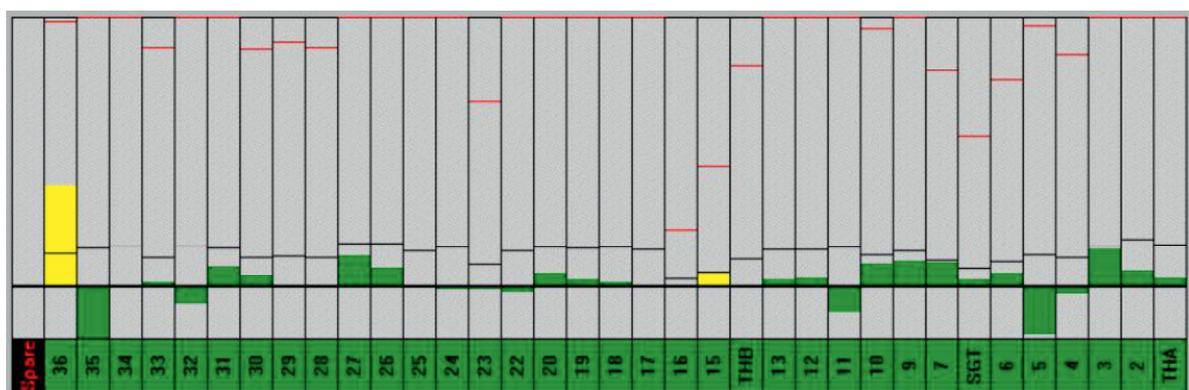
Figure 5: Illustrative diagram showing the operator window for finding small leaks. The water courses are numbered. Each column shows the adjusted dampened difference between water in and out of a course. The red limit is 4.5·standard deviation and the black line is the adjustable limit

Further, to meet the goal of detecting 60 l/h, the signal noise was dampened by using a moving average over several minutes. As expected, a longer moving average gives a better result. A two minute moving average has been chosen for the first implementation of this system. The standard deviation is then calculated for large set of data for the difference of each water course. An alarm is set for 4.5 times the standard deviation, since we know that all normal variation will be within this limit. This is shown as the red line in figure 5. The limit will be individual for each water course since the variation in difference is different for the different water courses. Further, since the water cooling system is closed, there is an alarm if more than 500 l of water is added to the water cooling system per 24 hours. This amounts to 20.8 l/h. To be able to locate which water course the leak is at, the data system is set up so that the dampened adjusted difference in flow is shown as a column for each water course. An adjustable alarm limit, where the column turns yellow if above the limit, has been added. This alarm limit is also based upon the standard deviation, and the limit is set for example as 200%·standard deviation. When the furnace operator identifies that there is a small leak somewhere in the system, the alarm limit can be constantly adjusted down, until one of the water courses more or less continuously turns yellow, as shown in figure 5. Tests done have shown that leaks down to approximately 45 l/h can easily be found by this system.
