# RAPID REDESIGN AND RESTART OF THE VALE ONÇA PUMA NICKEL SMELTER

## ABSTRACT

*Approximately 13 months into a challenging plant ramp-up, a series of furnace failures halted production at Vale's Onça-Puma ferronickel smelter in Pará State, Brazil. Rather than re-build the equipment 'in-kind' with the original furnace supplier, Vale chose to adopt a strategy of technologically upgrading the problem areas in the smelter. Significant step-change improvement was thereby achieved in furnace integrity (structural binding and cooling systems), slag tapping and the calcine transfer systems.*

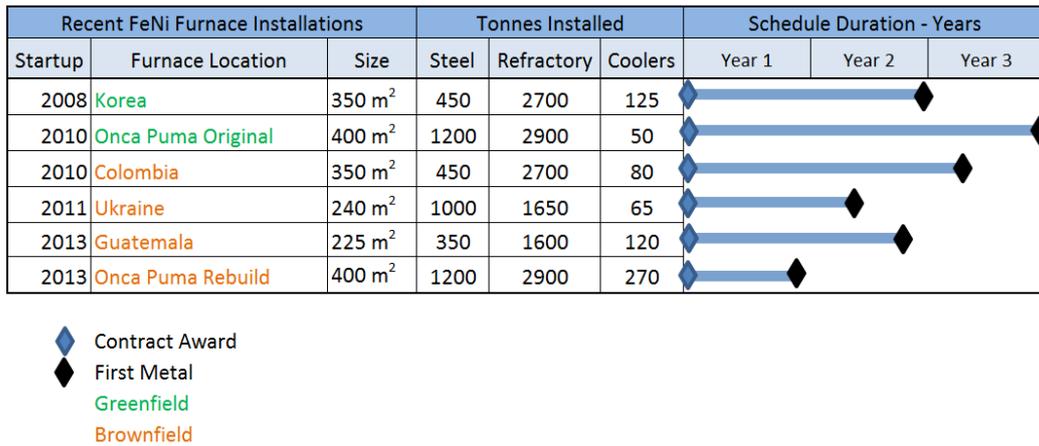
**Figure 1:** FeNi Furnace Construction - Onça Puma Versus Others

An integrated Vale-Hatch project team was established to execute the Furnace No. 1, Calcine Transfer System and Metal and Slag Tapping area upgrades, which were achieved in less than 1 year from start of detailed engineering to first metal tap. Figure 1 demonstrates the remarkable project turnaround time that could only be accomplished through close cooperation between Vale and Hatch.

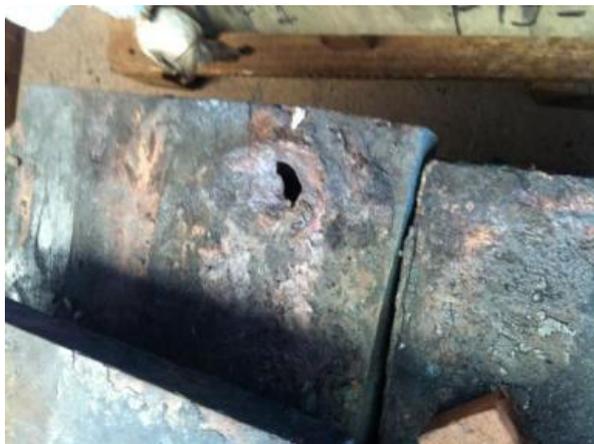
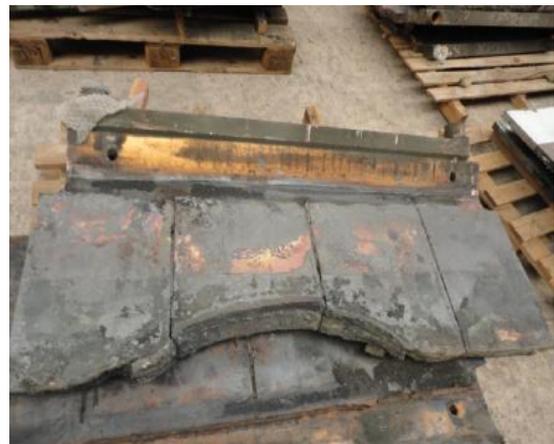
**Figure 2:** Damaged Coolers Removed from the Furnaces (Original Design by Others)

The existing coolers from both furnaces were carefully removed and inspected for reuse. One third of the coolers were found to have excessive corrosion, pitting, flaking of the chrome coating, and penciling which ruled them as unsalvageable, as shown in Figure 2. The poor condition of many of the coolers was unexpected due to their short operation duration. The reduced number of acceptable coolers required the cooler layout, and in turn the associated shell panels, to be quickly redesigned. The final design utilized new Hatch plate coolers in the high heat flux metal zone and a combination of new and reused coolers in the lower duty reserve slag capacity area.

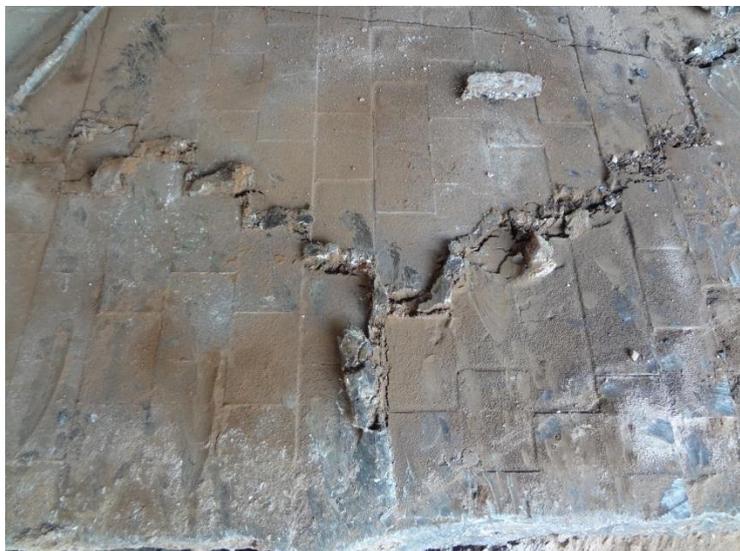
**Figure 4:** Onça Puma Hearth During Demolition

The original furnace design utilized a combination of a fixed frame design in the transverse direction and a more conventional sprung bound system in the longitudinal direction. A fixed frame design has the same limitations as a traditional round furnace; the system is unable to maintain tight brick joints during a cooling phase. The longitudinal binding system was not capable of maintaining brick joint tightness during cooldown which led to bath infiltration between the refractory bricks. The result was a highly infiltrated hearth as shown in Figure 4.

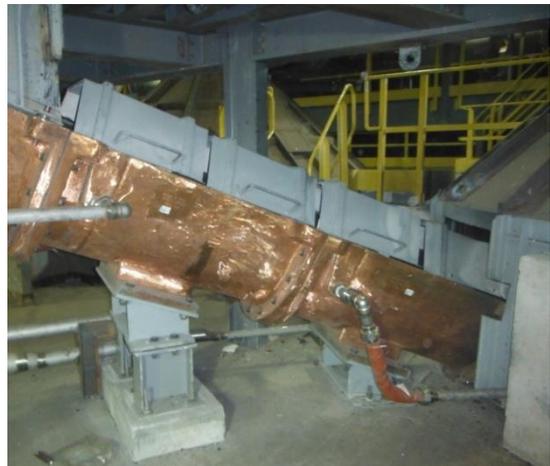
The launder profile was improved and a profile with a curved bottom and tapered sides implemented to minimize the wetted surface in contact with the molten slag flow. Implementation of these design changes has led to an observed reduction in formation of build-up on the launders. The build-up that does form, tends to be thinner and easier to break free of the launder surface when cleaning.

As a direct result of the design and operation improvements implemented, operators have reported that the launder cleaning operation now involves very little effort. This is proven by the time to clean the launders which is now less than 2 minutes which is reduced significantly from the cycle time of more than 60 minutes on the original furnace.
