# Challenges and solutions in PGM furnace operation: high matte temperature and copper cooler corrosion

## Synopsis

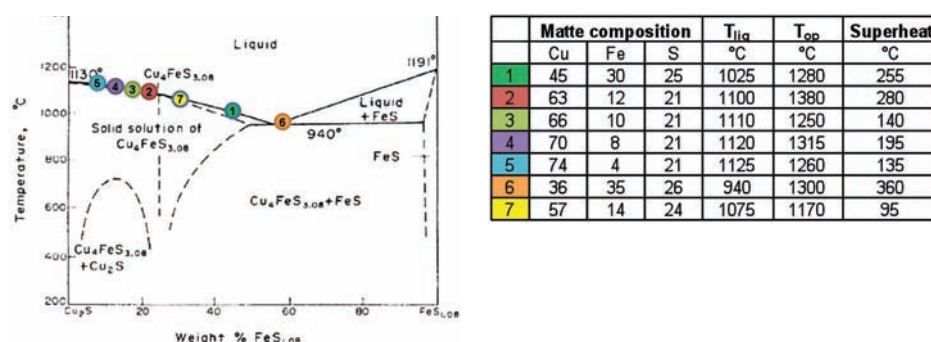
Figure 1—Copper primary matte liquidus temperatures (diagram after Schlegel and Schüller, 1952; matte composition information after Kapusta, 2004)

When one considers the copper matte formed in these furnaces, the matte liquidus temperatures range from around 940°C to around 1125°C, and a maximum difference of 360°C between the operating temperature and the matte liquidus temperature is observed (Figure 1).

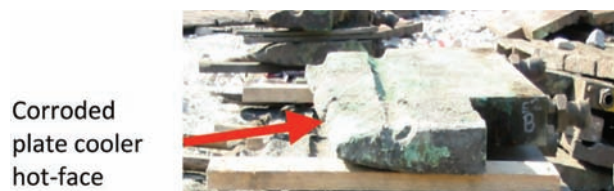
Figure 4—Severe upper plate cooler corrosion at Waterval Smelter. Note increased corrosion of upper plate cooler located in the furnace nearest the top of slag and concentrate interface

Corrosion is also not limited to waffle coolers. Given time, copper plate coolers in PGM furnaces are corroded to a short sharp edge (Figure 4), barely protruding into the furnace wall, and so reducing their cooling effect and upper wall stability. The corrosion is pervasive and continues to some extent throughout the furnace, not being limited to attack of copper, but also of basic magnesia-based refractories where magnesium sulphates (often resulting from sulphidation of

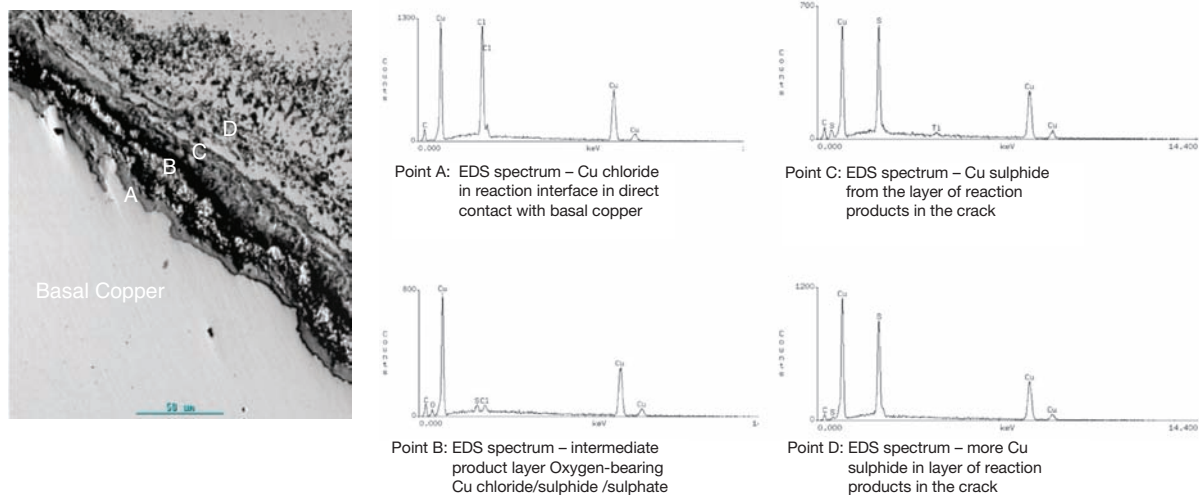
Figure 8—BSE image inside of a copper crack extending from a corrosion pit - typical sequence of corrosion product layers

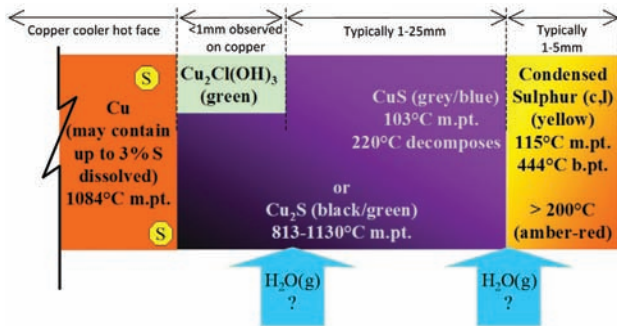
Figure 9—Schematic depiction of copper cooler and dominant species in its corrosion

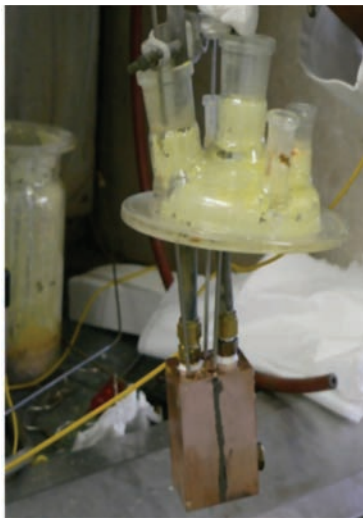
Figure 10—Suspended water-cooled copper test piece before insertion into test rig

To investigate this discrepancy, a special test rig was devised in an attempt to simulate copper cooler corrosion conditions. This comprised suspending water-cooled copper test blocks above a heated bath of sulphur, so exposing water-cooled copper to sulphur vapour (Figures 10–13). The results demonstrated that some direct sulphidation of water-cooled

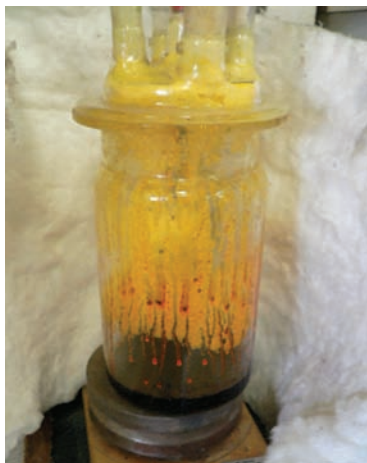
Figure 11—Sulphidation test rig with test sample inserted. Sulphur condensing and running down to liquid bath

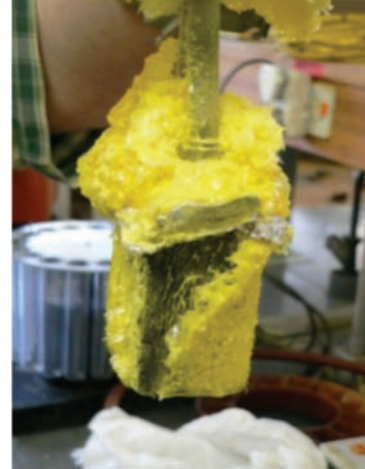
Figure 12—Water-cooled copper specimen coated with sulphur after testing

copper was indeed feasible even at a temperature as low as 25°C (0.2 mm over 14 days or 5.2 mm/a). As the copper temperature is raised to 90°C the corrosion rate increases to 16 mm/a. At a copper temperature of 125°C, the rate is

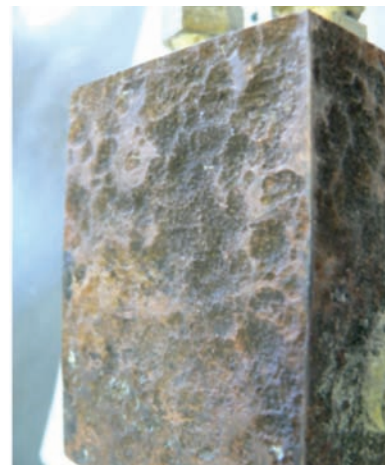
Figure 13—Copper corrosion at low 50°C temperature after only 5 days' exposure

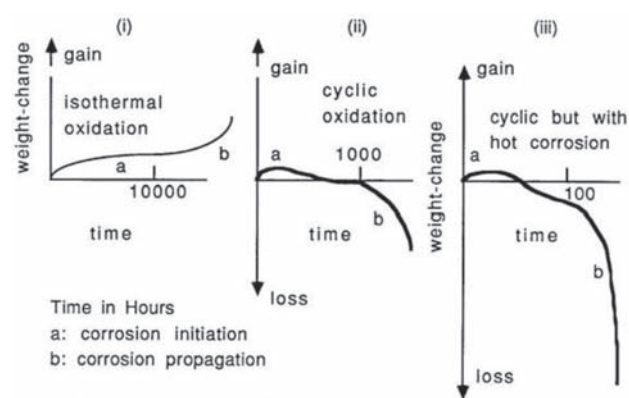
Figure 14—Corrosion mode typical of hot corrosion systems (after Hocking *et al.*, 1989)

The rate of 'hot corrosion' (by definition, corrosion in the presence of sulphur species) is inherently highly non-linear with respect to time (Figure 14). Coupled with the specific cooler conditions described above, this will further contribute

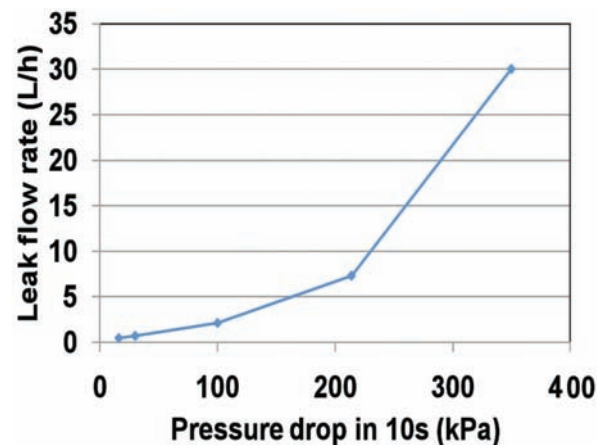
Figure 16—Leak simulation testing results indicating system sensitivity (Mahape, 2005)

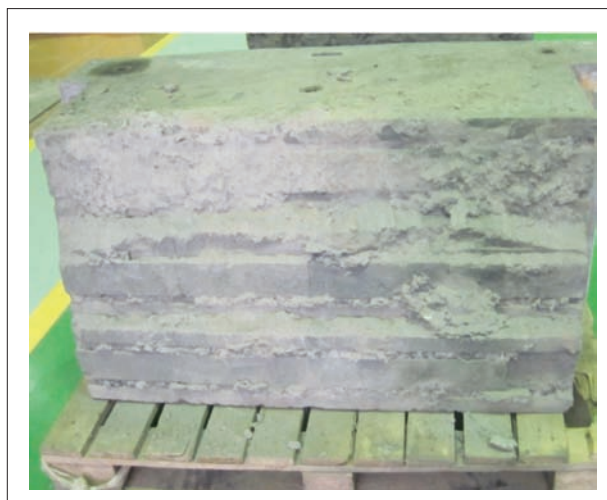
Figure 19—Perfect lower cooler graphite hot-face after being installed in the furnace for 12 months

Two consecutive planned annual inspections of the latest generation of graphite-protected copper coolers revealed the graphite to be in near pristine condition after 12 months' service. Given that the life of the original coolers was approximately one year, these results are very positive.
